Safety Inspection Report

Annual Inspection

Coaley Play Area

Coaley Parish Council

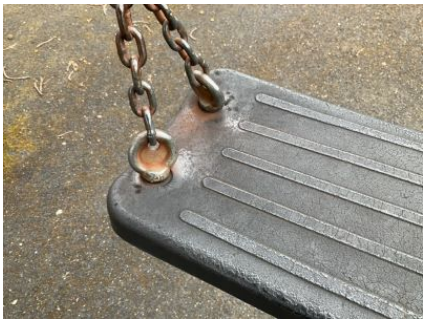
Loose swing seat eye-bolts.

Tighten connecting nuts.
